Cascades Female Factory South Hobart

Conservation Management Plan

Prepared for
Tasmanian Department of Tourism Arts & Environment

June 2007

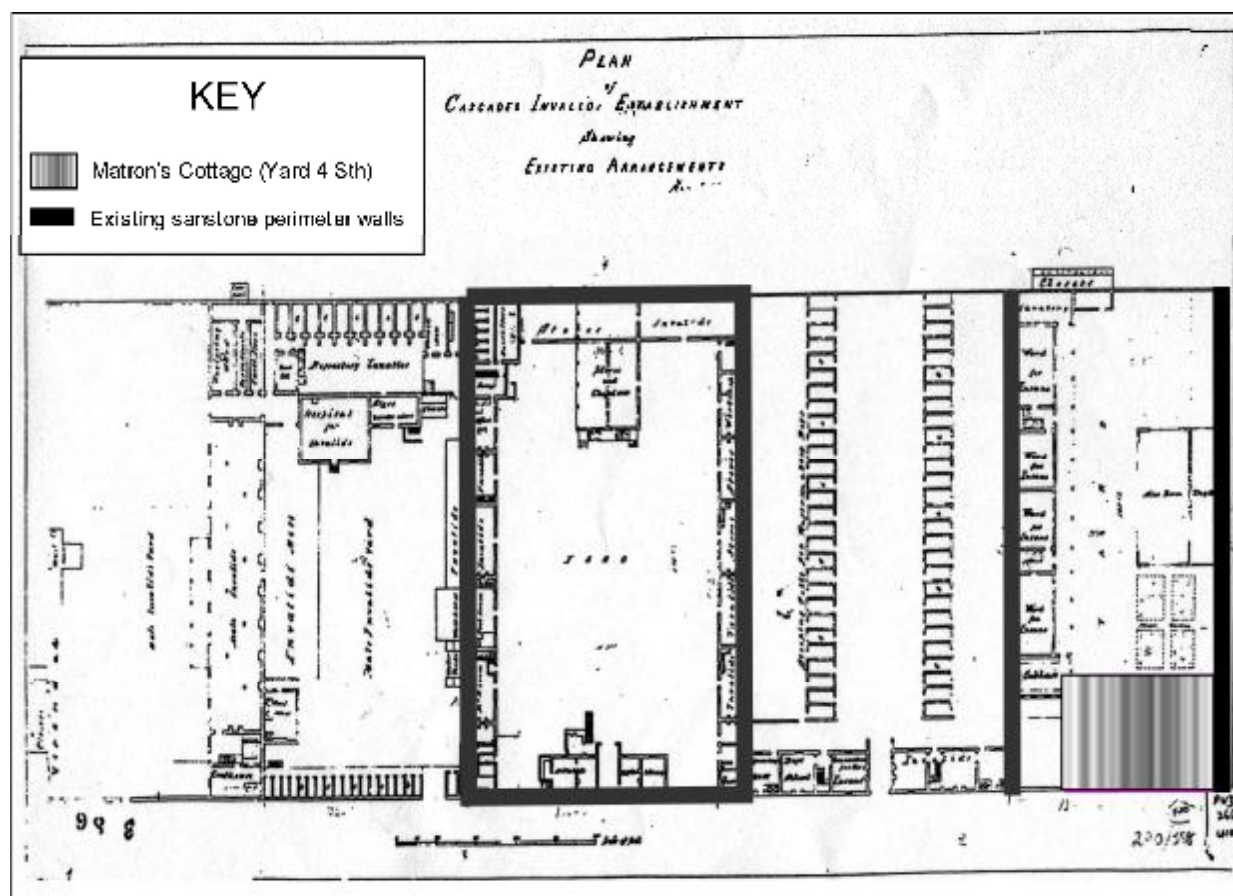
Figure 15 C.1876 survey plan of the Cascades Female Factory with surviving above ground fabric highlighted.

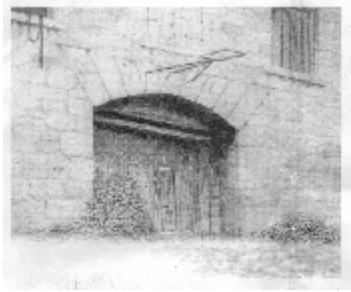
No.	Yard 1 Description	Context condition	Historic diagram/ photograph
01	<p>Yard 1 entrance</p> <p>The entrance consisted of a 3.5 x 3 metre high centrally situated opening in southern aspect of perimeter wall. This opening was originally arched and gated when constructed in c1824, however in c1960s the gates and archway were removed and a concrete lintel inserted to create a higher clearance.</p>	Surviving extant fabric

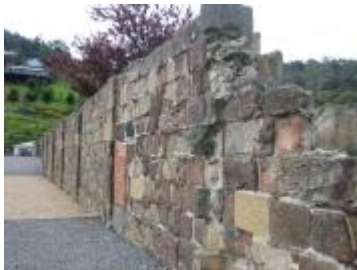
No.	Yard 3 Description	Context condition	Historic diagram/ photograph
33	<p>Yard 3 perimeter wall</p> <p>A 60 x 45 metre wide enclosure wall surrounding Yard 3 infrastructure was built when the yard was first laid out between c1842-1845. Today only the eastern and western walls survive to a general height of 4.5 metres. Constituent fabric consists of lime mortared ashlar/rubble sandstone with occasional brick or concrete block patching.</p>	Extant walls with patching

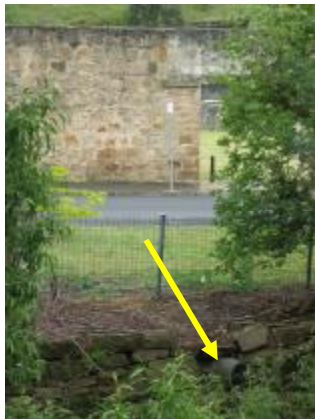
No	Associated Elements Description	Context condition	Historic diagram/ photograph
86	<p>Yard 3 underground storm water piping system</p> <p>Sandstone/masonry lined storm water drainage network from Yard 1 and/or 2 discharging into Hobart Rivulet. A similar better documented system is recorded in Yard 3 and appears as feature 38.</p>	Surviving sub-surface archaeological feature

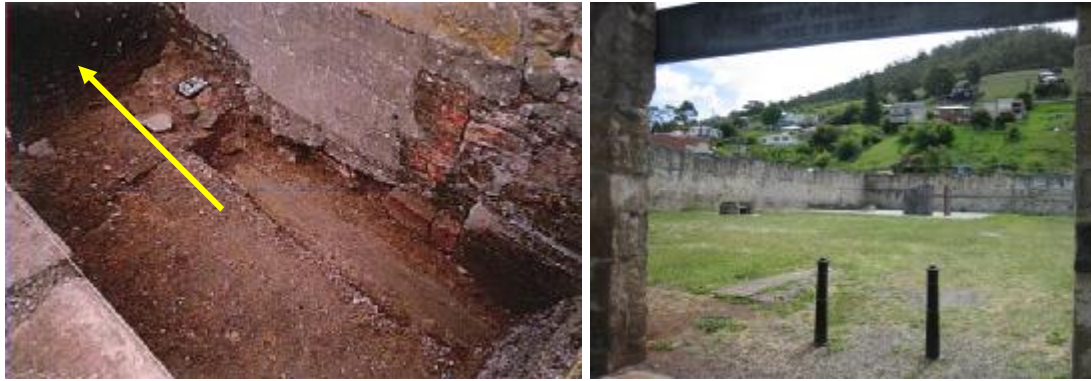
Figure 16 Detail view of Yard 1 test excavation and general view of Yard 1 looking north. Note depth of 750mm+ overburden/fill layers above historic footings at left.

These speculations can appear more credible if one considers the amount of demolition material that would have been generated when all the resident buildings were destroyed in one singular demolition act. The resulting mass of demolition waste would have required removal if it was not instead merely compacted on site as fill, and a new working level established on top of this. Therefore, the archaeological potential of Yard 1 is deemed to be HIGH.

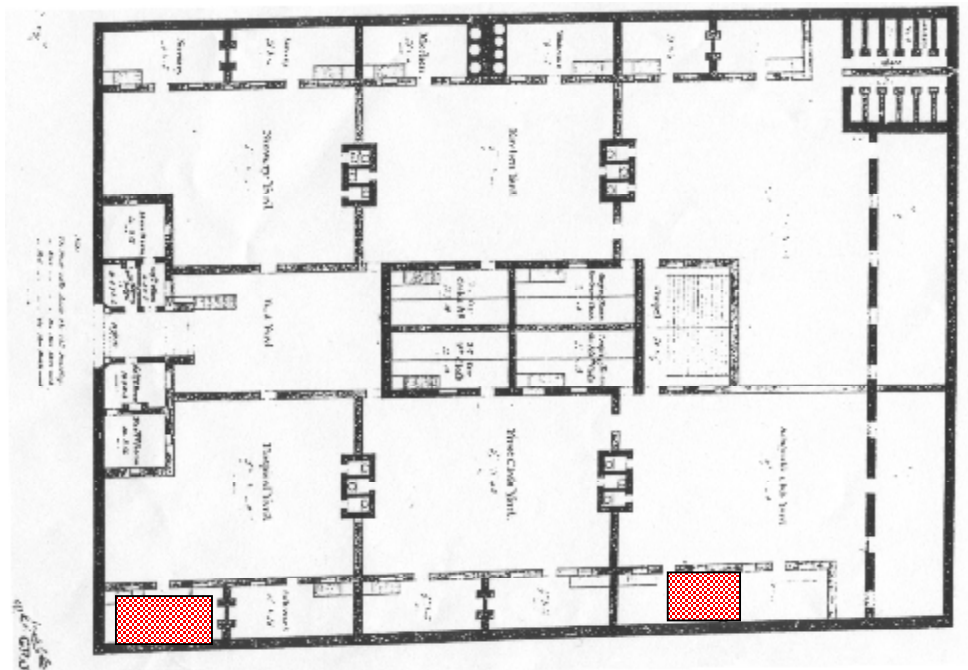
Figure 17 Archer's 1820s design/plan for Yard 1 showing elaborate building floor plan, the footings of which are highly likely to remain in an excellent state of preservation. Test excavations by Kostoglou (2001) are highlighted in red.

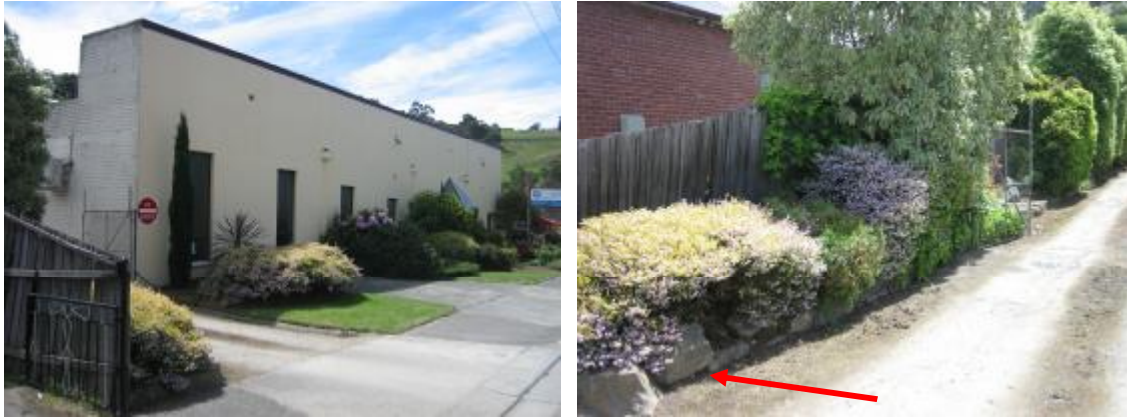
Figure 18 Current views of the church building and the western driveway boundary of the church property. Note the in situ sandstone wall footing running the length of the driveway.

No archaeological excavation work has been undertaken within the former yard. However, the garden beds occupying the western side of the former yard appear to have remnant sandstone wall footings which may indicate that sub-surface archaeological vestiges of the Yard 2 perimeter wall survive. It is also possible that building footings within the yard also survive, although the depth of construction for the current factory/church building may have obliterated these in the southern half of the site. Based on these considerations, the archaeological potential of Yard 2 is generally deemed to be MEDIUM, although further research may show that areas within the yard, outside the extent of the factory/church building, may be of higher archaeological potential.

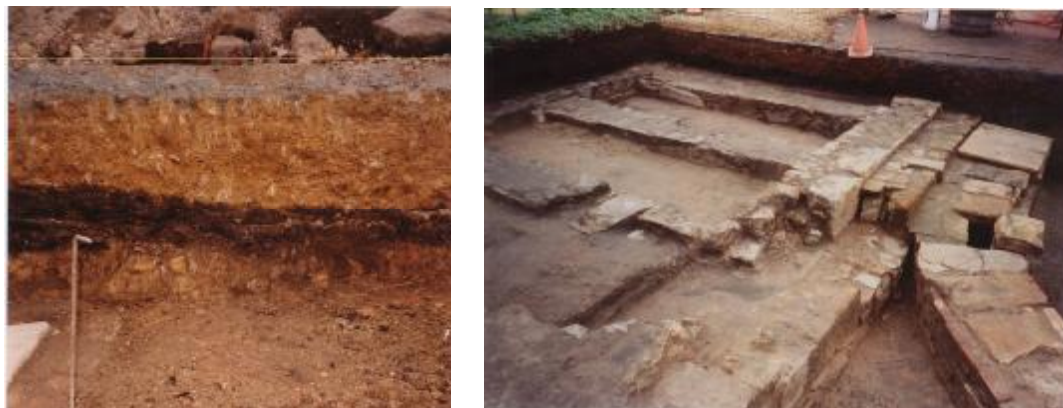
Figure 19 Views showing depth of overburden/fill and resulting solitary apartment footings from test excavations in Yard 3.

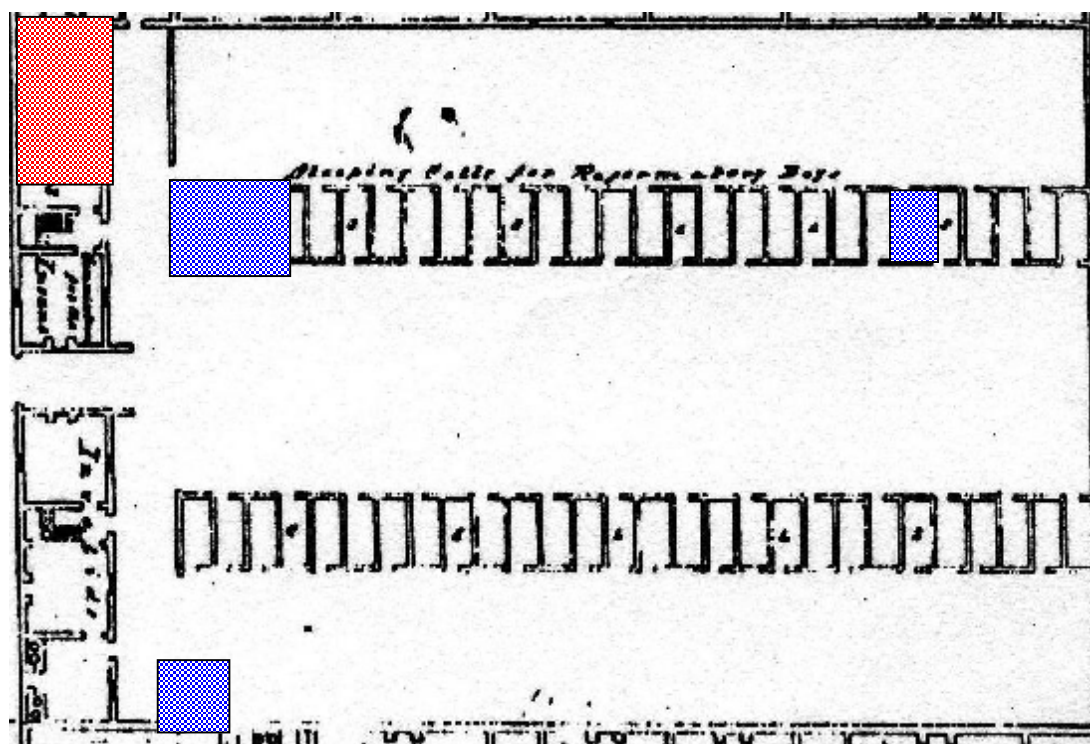
Figure 20 1840s plan/design for Yard 3 showing two solitary apartment blocks that should essentially remain intact below the ground. Test excavations by Searle (1996) and Kostoglou (2001) are highlighted in red and blue respectively.

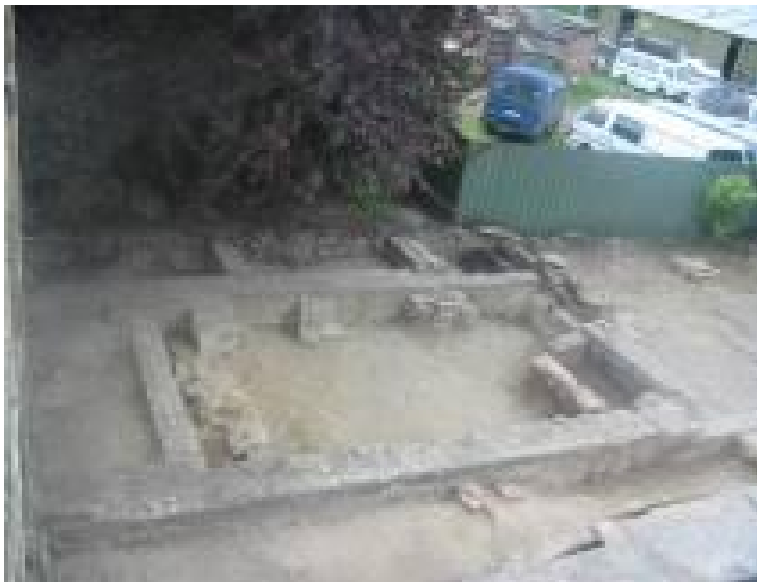
Figure 21 View of Yard 4 South excavation prior to backfilling. Note intact Cookhouse and Nursery footings striking north (top of picture) beneath property boundary.

Based on these considerations, the archaeological potential of Yard 4, including Yard 4 North, is deemed to be HIGH, acknowledging also that excavations have confirmed the potential for Yard 4 South.

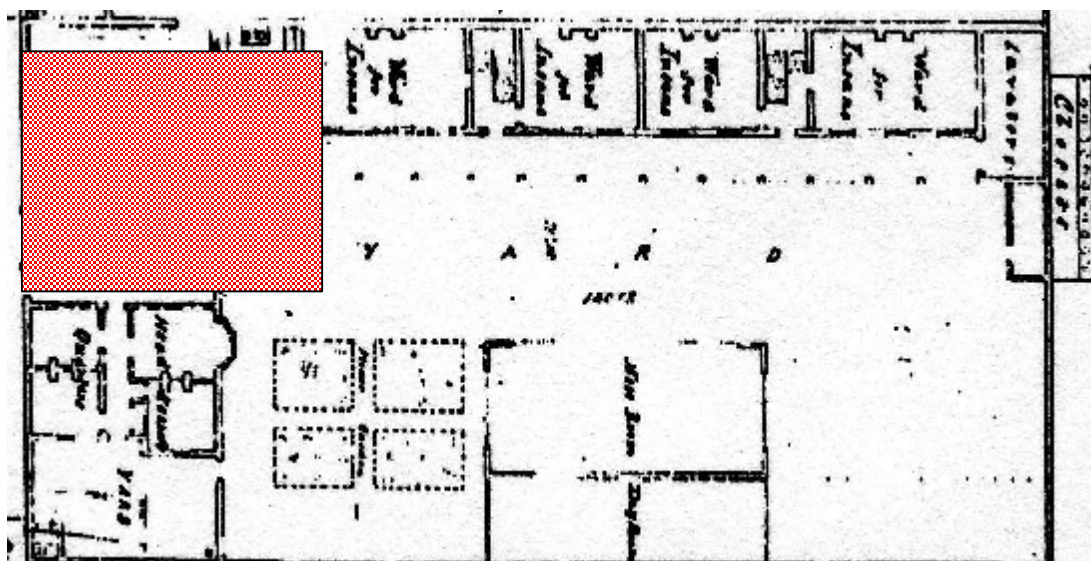
Figure 22 1870s plan of Yard 4 showing major structures along west wall, although buildings along the east wall also appear in old photographs. Excavations by Kostoglou (2006) are shown highlighted in red.

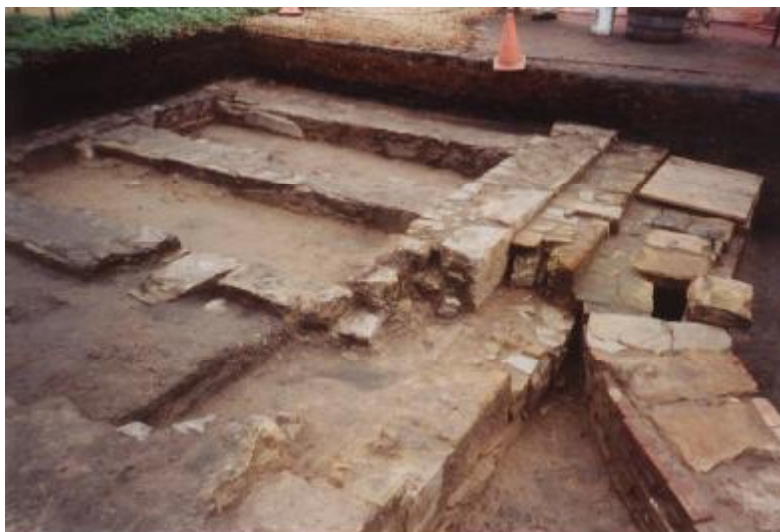
Figure 29 View of Yard 3 excavation undertaken by Kostoglou (2002). This image shows exposed footings shortly after excavation.

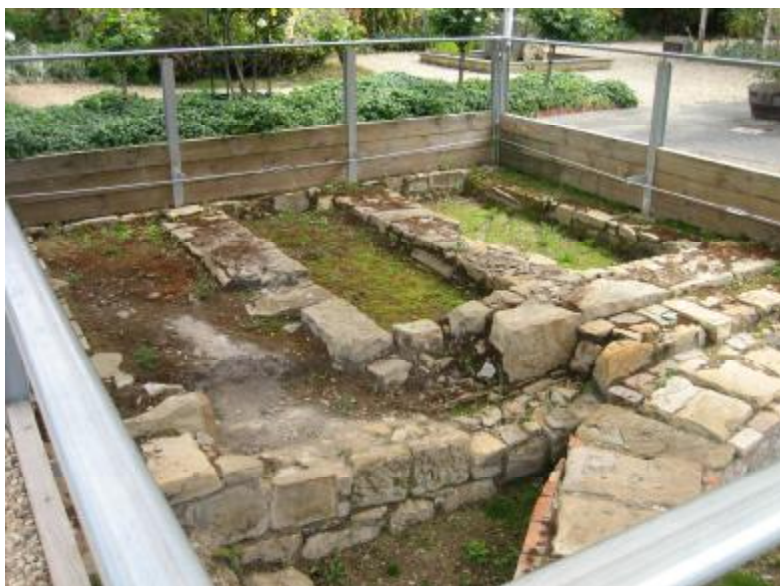
Figure 30 This image shows the same view today. Note vegetation encroachment and mortar deterioration both due to excessive rainwater.

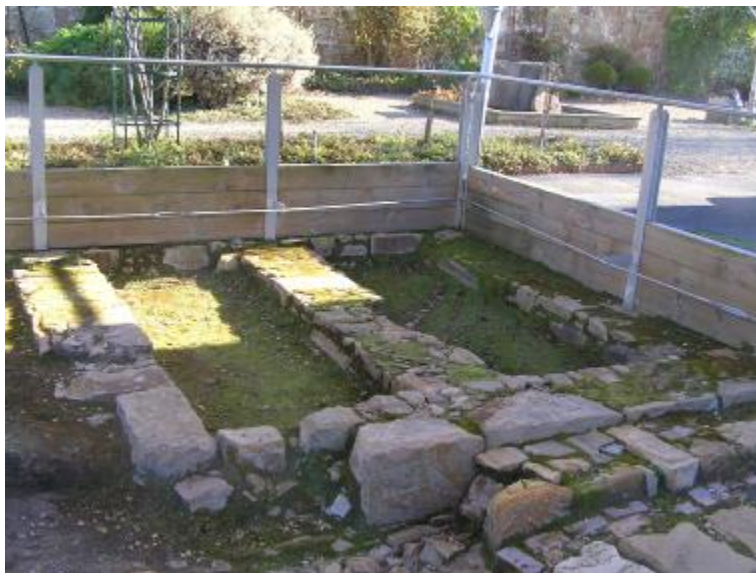
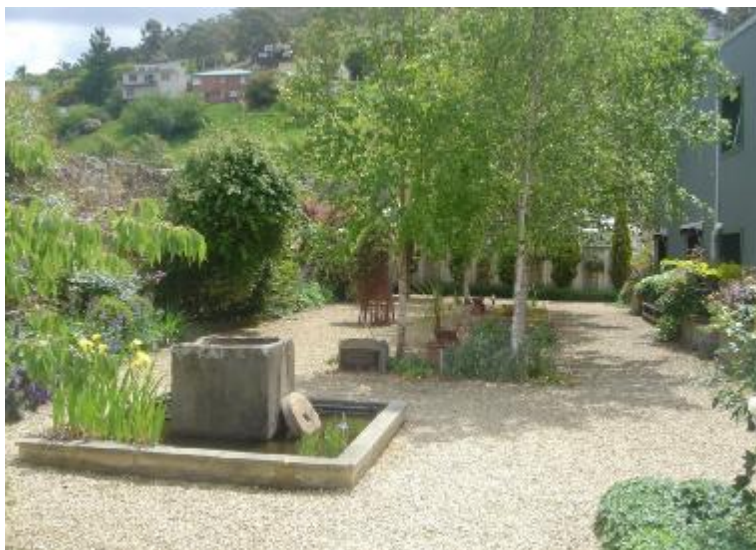
Figure 6 (From top) exposed 2001 excavation in south area of yard; landscaping on west side of factory building; view of south-east corner of yard.

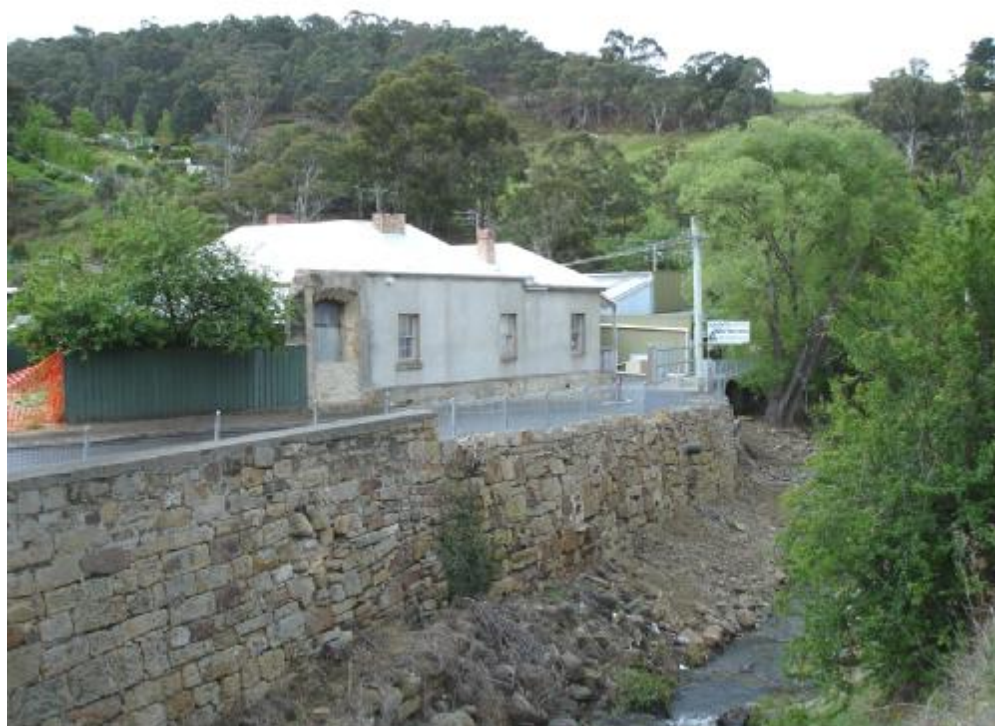
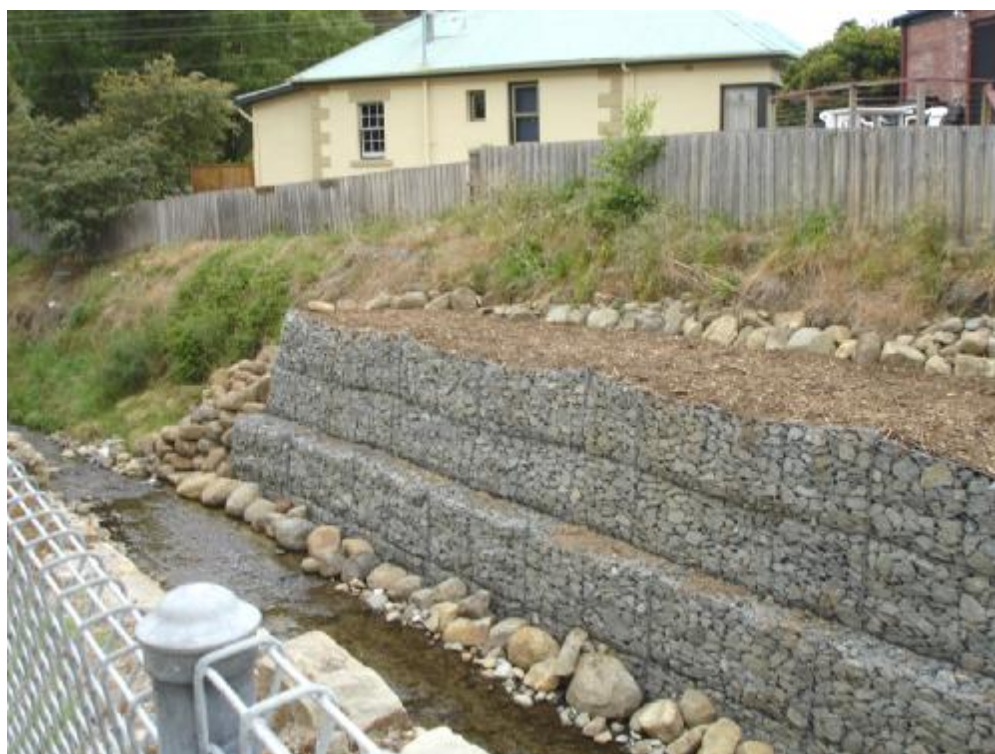
Figure 29 Views of the rivulet, including stone-work and retaining work. The Matron's Cottage in Yard 4 South is visible in top picture, and 31 Apsley Street is visible in bottom picture.

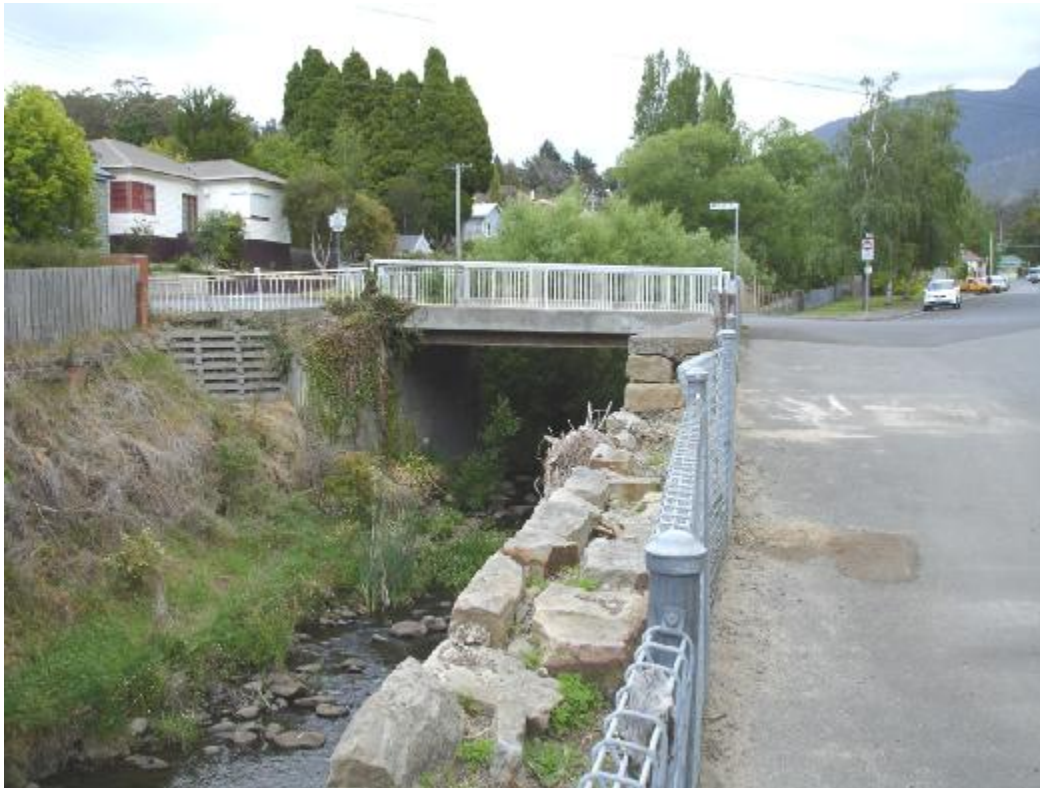
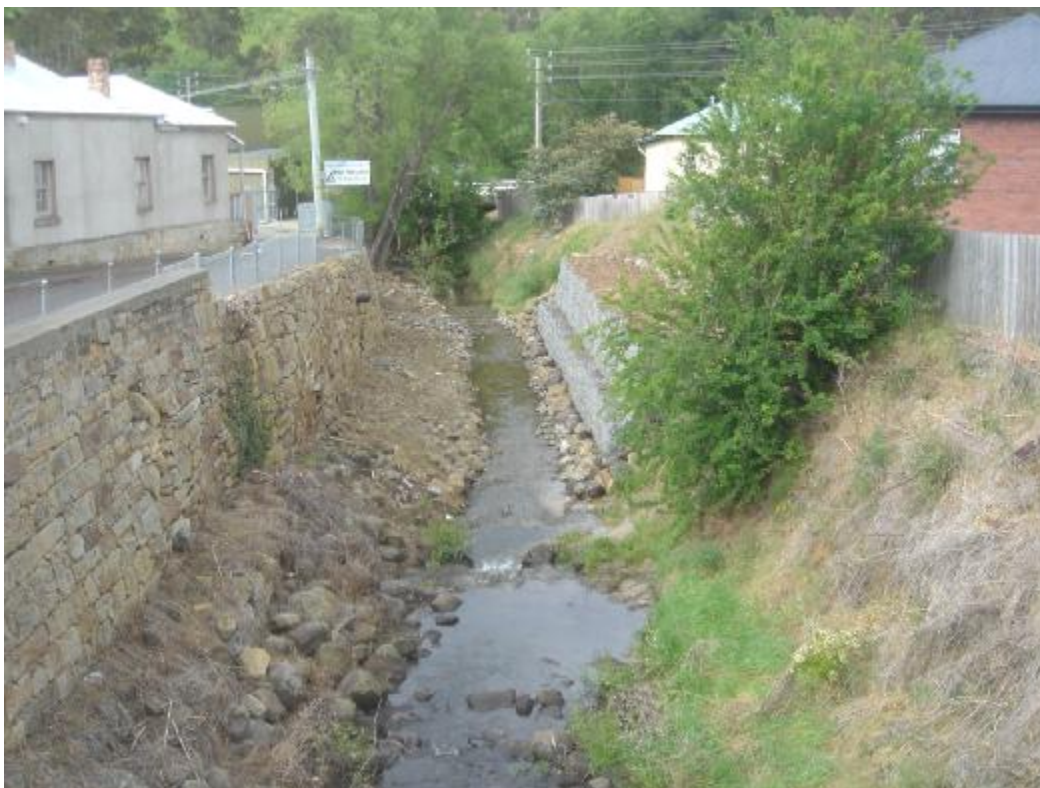
Figure 30 Views of the rivulet and stonework, looking west (top) and east (bottom).
