CASCADES FEMALE FACTORY THE MATRON'S QUARTERS

Conservation Management Plan PART 1

FINAL

September 2012

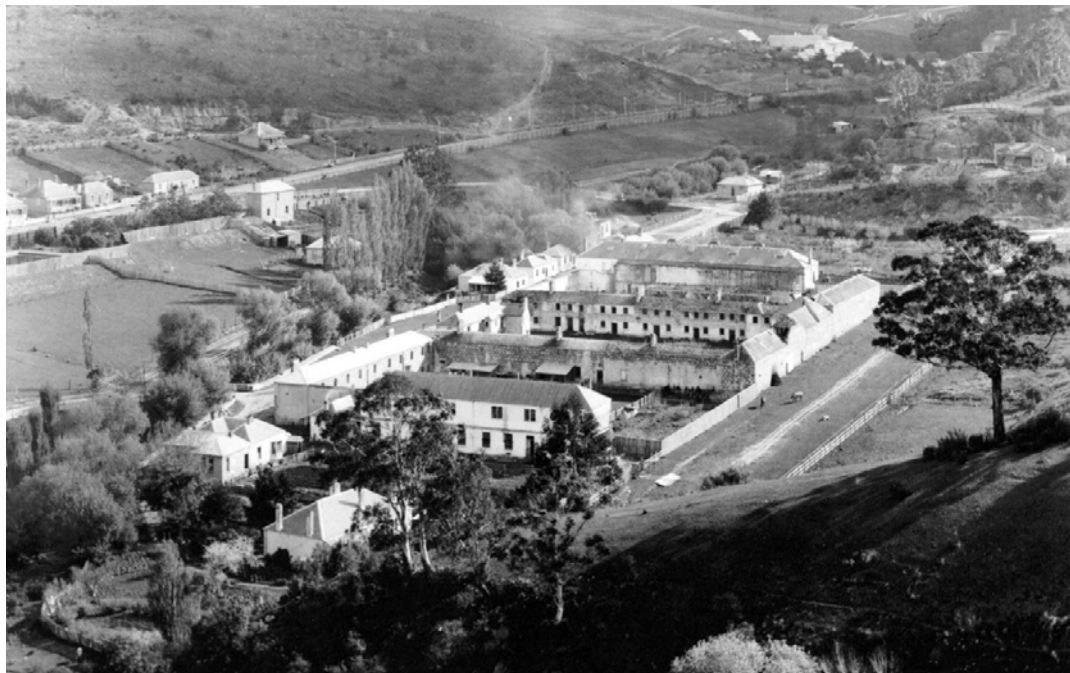
Figure 3: View of Cascades Female Factory looking from the north east, post 1905 showing the eastern additions to The Matron's Quarters (located at the bottom left of the complex). Source: Image No. AOT NS 1013/1453 in McConnell, *Cascades Female Factory Preliminary Landscape Assessment*, Sept 2007.

The third period of the history of the place was its use as a private residence after the entire property was auctioned off by the government in 1904. The Matron's Quarters was bought by Henry Jones IXL along with the nursery buildings in Yard 4. It was during the early 1900s that additions were made to the dwelling. This included some demolition of Yard 4 walls and a two room addition plus verandah to the east of the original form.⁴ This gave the building a street frontage and entry from Degraives Lane (refer to Fig 3).

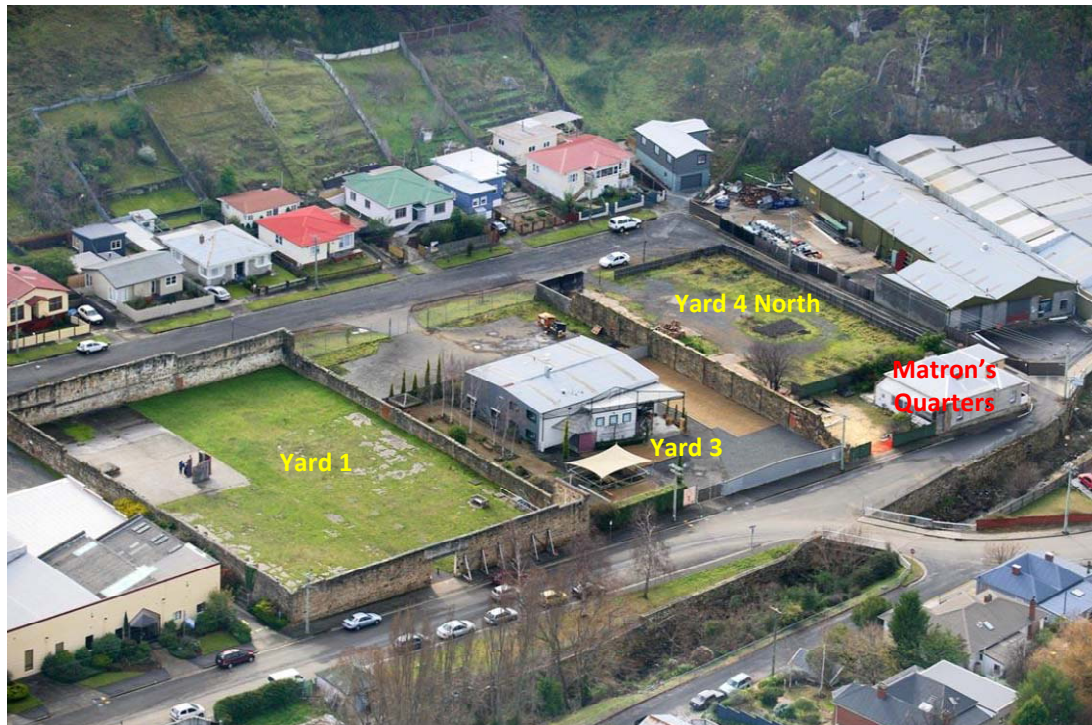
Figure 4: Cascade Female Factory pre 2009. Source: PAHSMA, modified by HLCD.

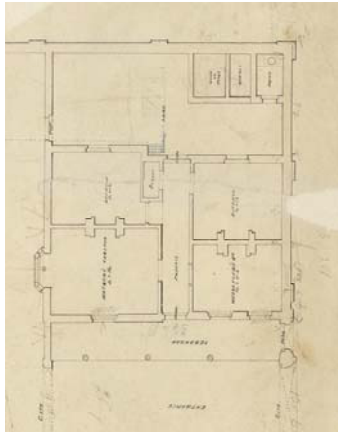
YEAR/SOURCE	DESCRIPTION	PLAN/PHOTO
<p>Floor plan and elevations for Yard 4 including The Matron's Quarters, dated 12th July 1849.</p> <p>Source: Tasmanian Archive and Heritage Office, PWD 2661398</p>	<p>In c1850, The Matron's Quarters were constructed within Yard 4; the first separate residence provided for a matron on site. The plans show a domestic four room cottage with central passageway, front verandah, enclosed yard to the east with store and wood/coal, ash pit and privy.</p> <p>Distinctive aspects of the plan are: entry within the site and away from the street; continuous walls to the south and east with no windows; the Messenger's Room not connected to the rest of the cottage and with a separate front door; and the bay window to the north in the Parlour.</p>

<p>Floor plan 1849 prior to construction (Degraves Street to the right)</p>
<p>Floor plan and elevations for Yard 4 including The Matron's Quarters, dated 12th July 1849.</p> <p>Source: Tasmanian Archive and Heritage Office, PWD 2661398</p>	<p>The elevation shows the separate entries for the Matron and Messenger.</p> <p>The roof form is shown without a hip to the external wall to Degraves Street.</p>

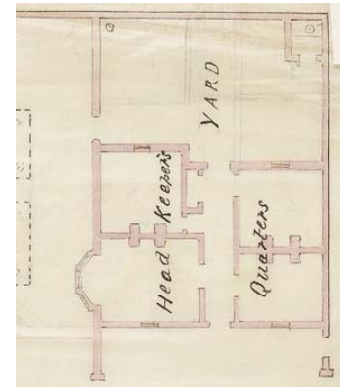
<p>Floor plan 1877 (Degraves Street to the right)</p>

<p>1877</p> <p>Source: Tasmanian Archive and Heritage Office, PWD 2661410</p>	<p>This is a simple plan after construction of the building. The Matron's Quarters had largely the same layout, except the Messenger's Room is shown with an internal door connected to the rest of the cottage and no separate external entry. Physical evidence demonstrates that the external door to the Messenger's Room was filled in at a later date. It is also possible that the internal door was originally an exterior one.</p>

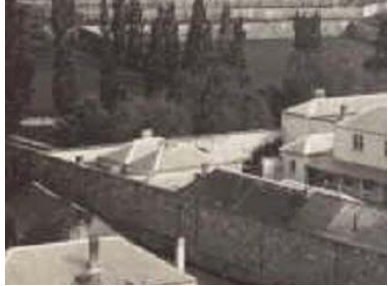
YEAR/SOURCE	DESCRIPTION	PLAN/PHOTO
	The store for wood/coal and ash pit does not appear. It is not known whether this is a change or whether the building was not constructed as per the 1849 drawings in this regard.	
c.1900 Source: State Library Victoria, SLV a08326 State Library of Tasmania, NS1013-1-45.	These two photographs from c.1900 show The Matron's Quarters prior to its extension and with the factory walls still intact. This demonstrates that the roof form was unlikely to have ever been constructed as shown in the 1849 elevation. The slate roof is evident as well as buttresses to the sandstone walls.

<p>Photograph c. 1900s</p>   <p>Photograph c. 1900s</p>
Post 1904 Source: AOT NS1013/1453	The eastern wall to Yard 4 has been removed. An addition to the east of The Matron's Quarters has been completed, with a separate L-shaped roof form and two chimneys. This provided a new street entry to Degraives Lane and two additional rooms. The bay window is intact. An outside toilet attached to the north west corner of the cottage is seen in this photo. Also the wall to the yard on the north has become part of the building addition with a doorway in place of the previous opening.	  <p>Post 1904</p>

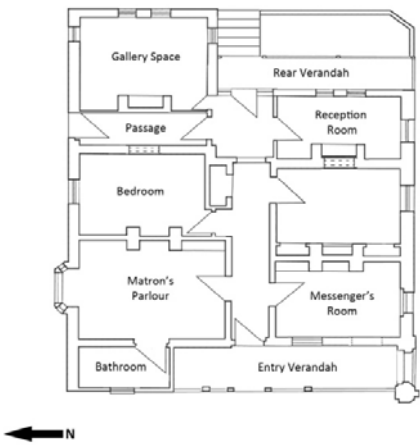
Current floor plan

YEAR/SOURCE	DESCRIPTION	PLAN/PHOTO
Current Source: ERM, modified by HLCD	The current floor plan shows that part of the original verandah was filled in for construction of a bathroom and the window was converted to a door. The outdoor toilet on the north was demolished. The addition to the east meant that two windows in the eastern wall of the c1850 residence have been covered.

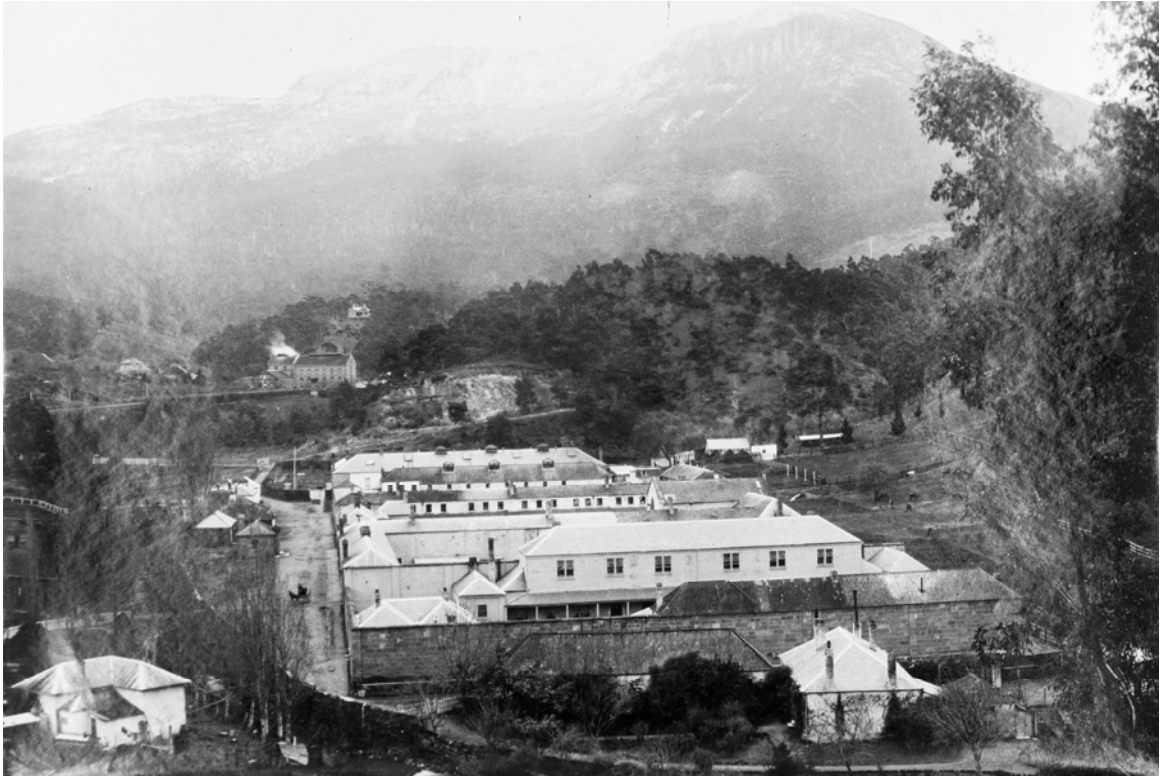
Figure 6: Photograph of Cascades Female Factory with The Matron's Quarters at the bottom left. This photograph was taken in c.1900, prior to the extension to the east which was made after the place was auctioned in 1904. Source: State Library of Tasmania, NS1013-1-45.

This can first be seen in an 1859 plan and in historic photographs from the time (refer to Figure 6). Its form and materials are similar to that of No. 17 and it may have been constructed during the period that Yards 4 and 5 were developed. Similar to No. 17, this is a single storey brick cottage with sandstone quoins, however there has been modification including an extension to the west near the front doorway and non-original brickwork around one of the windows.

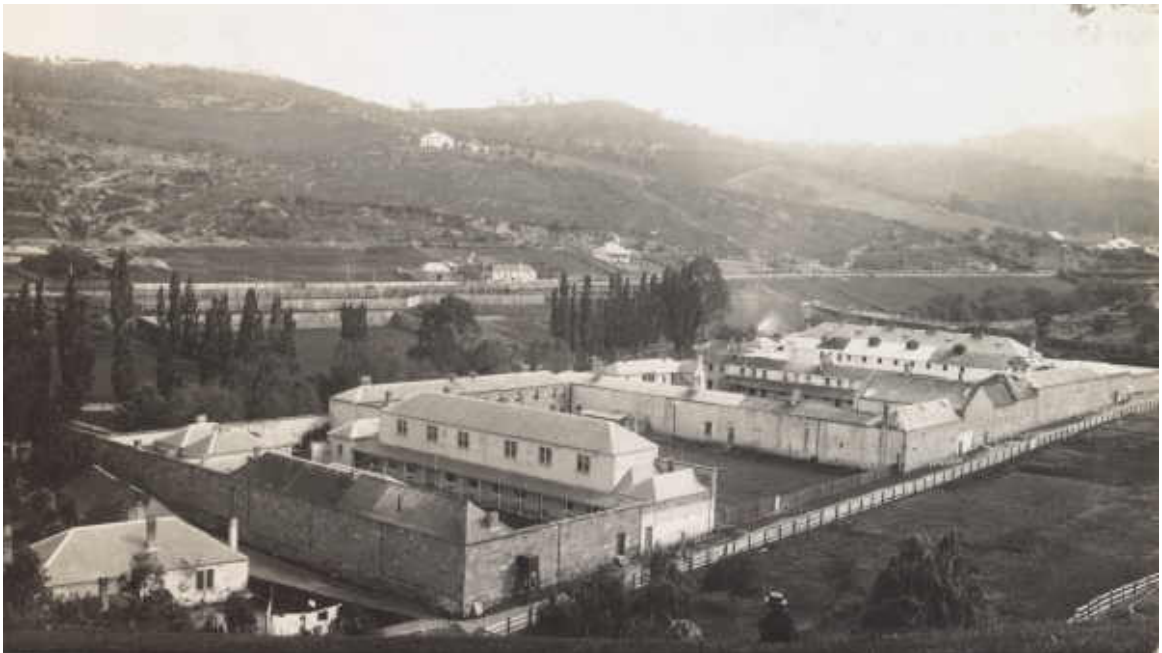
Figure 7: Photograph of Cascades Female Factory with The Matron's Quarters at the bottom left within the yard walls. This photograph was taken in c.1900, prior to the extension to the east which was made after the place was auctioned in 1904. Source: State Library Victoria, Image No. a08326

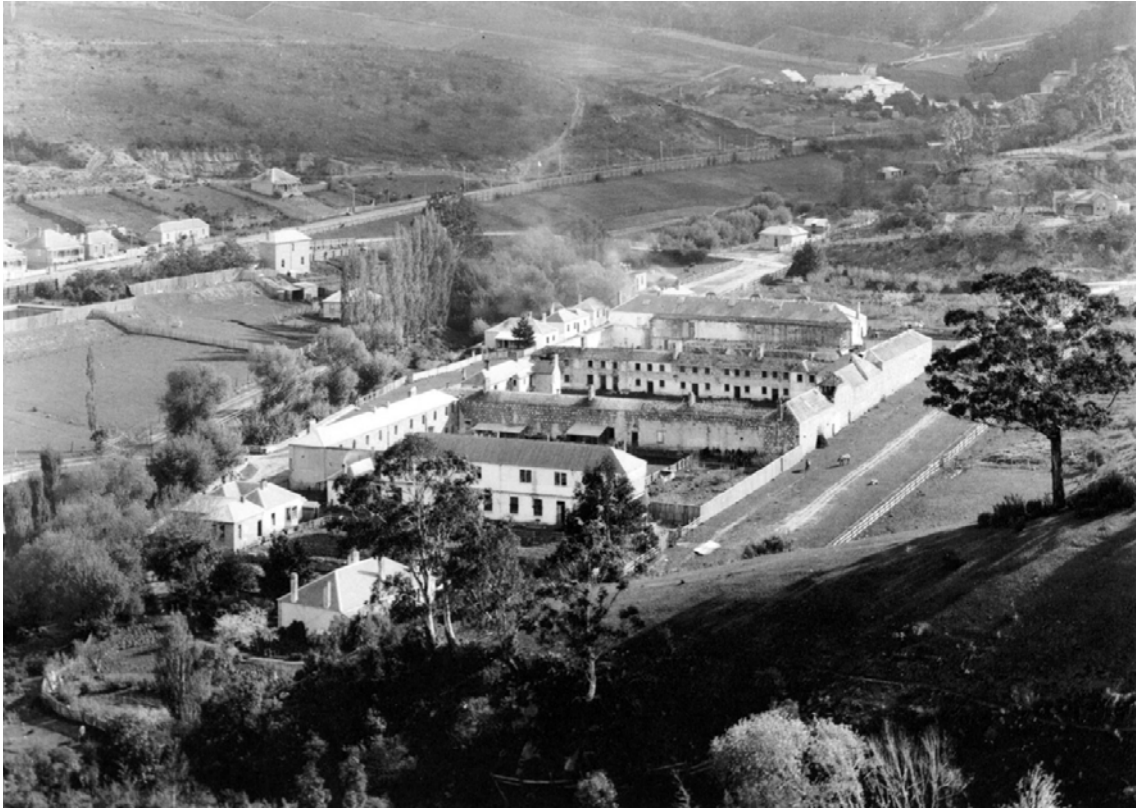
Figure 8: Cascades Female Factory, post 1905 as the eastern extension to The Matron's Quarters has been completed (note the roof form) and prior to the nursery building fire in 1929. Source: McConnell (Sept 2007) Cascades Female Factory Preliminary Landscape Assessment. Reference given: AOT NS1013/1453.

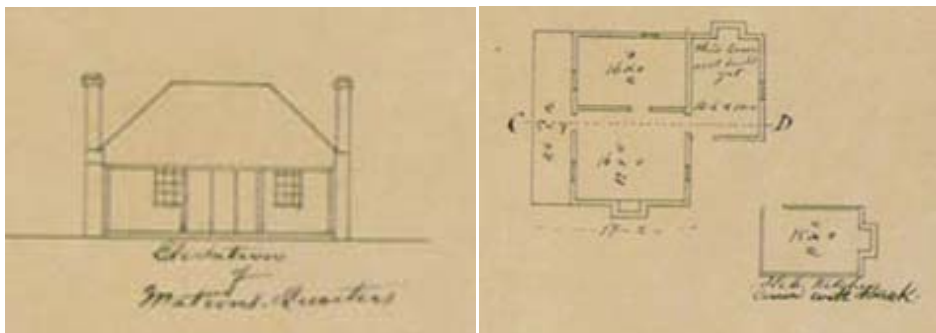
Figure 12: Plans for the Matron's Quarters at Eagle Farm, dated 28 September 1839. Source: State Archives Queensland, Item ID: 659611

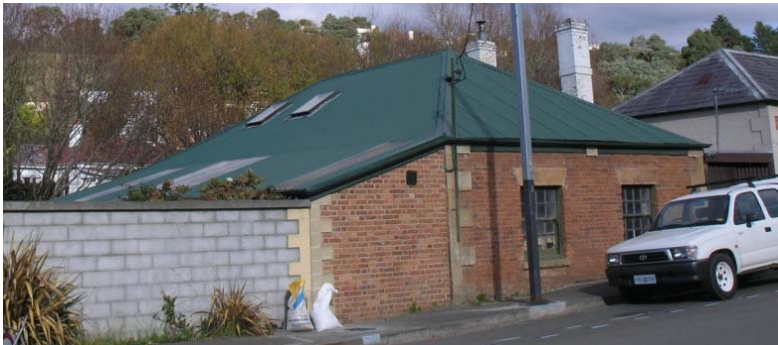
This dwelling was constructed prior to 1845 as it can be seen in J. S. Prout's drawing of the area from that year. It is a simple masonry cottage with sandstone quoins, sash windows and corrugated iron roof. There is also a small skillion-roofed addition. It is likely that the place was used by the Cascades Female Factory for staff quarters. This is a single storey brick cottage with sandstone quoins with two windows facing Degrares Street and a recent concrete block wall extending from the rear of the dwelling. Access to the building is via the gate from Degrares Street.

Figure 16: 17 Degrares Street. Source: HLCD Pty Ltd, May 2012

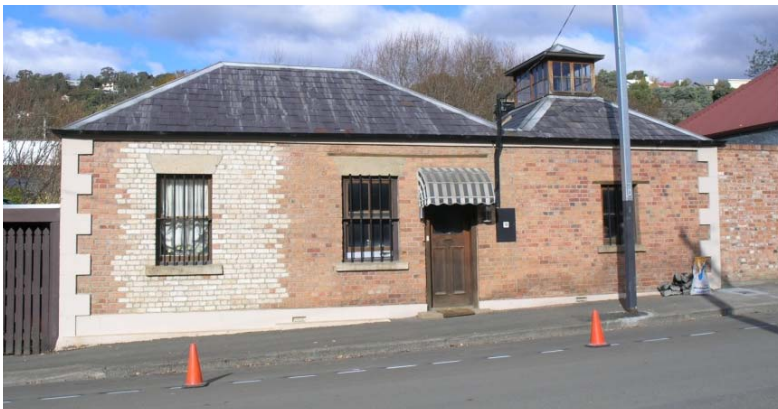
Figure 17: 19 Degrares Street. Source: HLCD Pty Ltd, May 2012

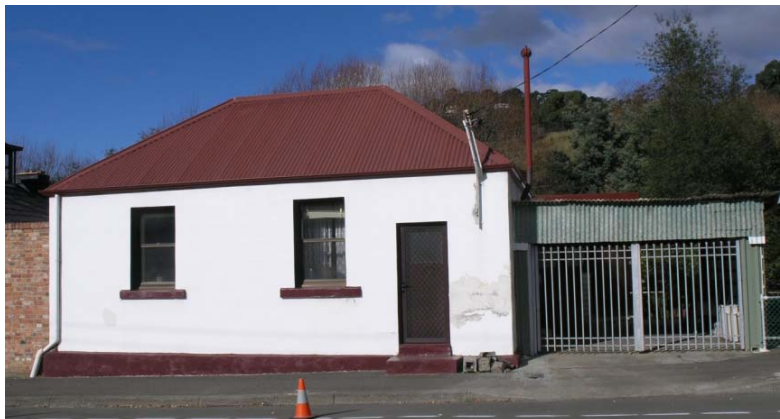
No. 21 Degrares Street first appeared in plans dated 1892. It is a simple Colonial Georgian, single storey, rendered dwelling with corrugated iron roof. Along with the neighbouring buildings at No.s 17 and 19, it is understood to have been used for staff accommodation.

Figure 18: 21 Degrares Street. Source: HLCD Pty Ltd, May 2012

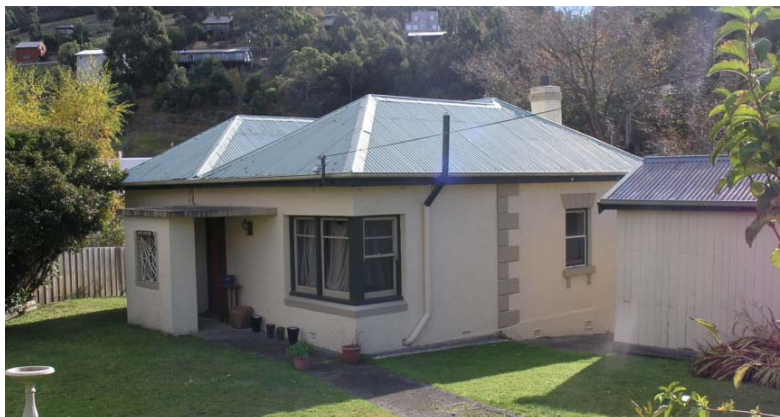
31 Apsley Street appears in plans from 1859. In the early 20th Century, the Home of Mercy operated out of this building after moving out of Yard 4 where it had been housed since 1896.¹¹ The single storey dwelling is rendered with quoining still intact and stone lintels and sills however it has been modified as seen in the entry porch and corner window.

Figure 19: 31 Apsley Street. Source: HLCD Pty Ltd, May 2012

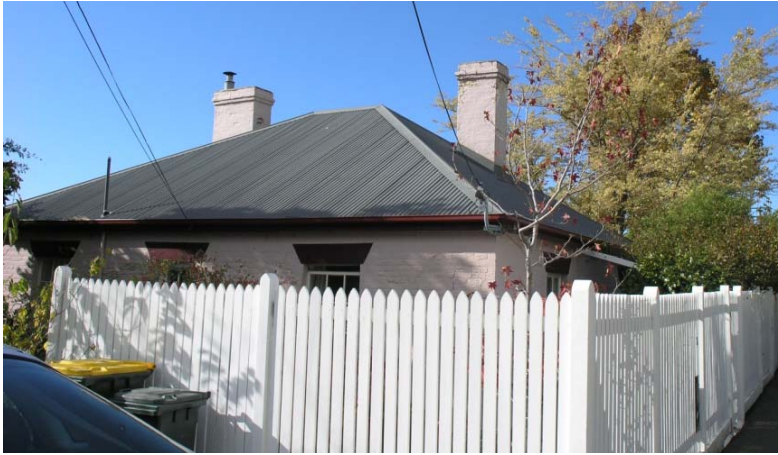
not been confirmed.¹² It has similar form to the dwelling described above. It is masonry (now painted) with a corrugated iron roof.

Figure 20: 3 Apsley Street. Source: HLCD Pty Ltd, May 2012

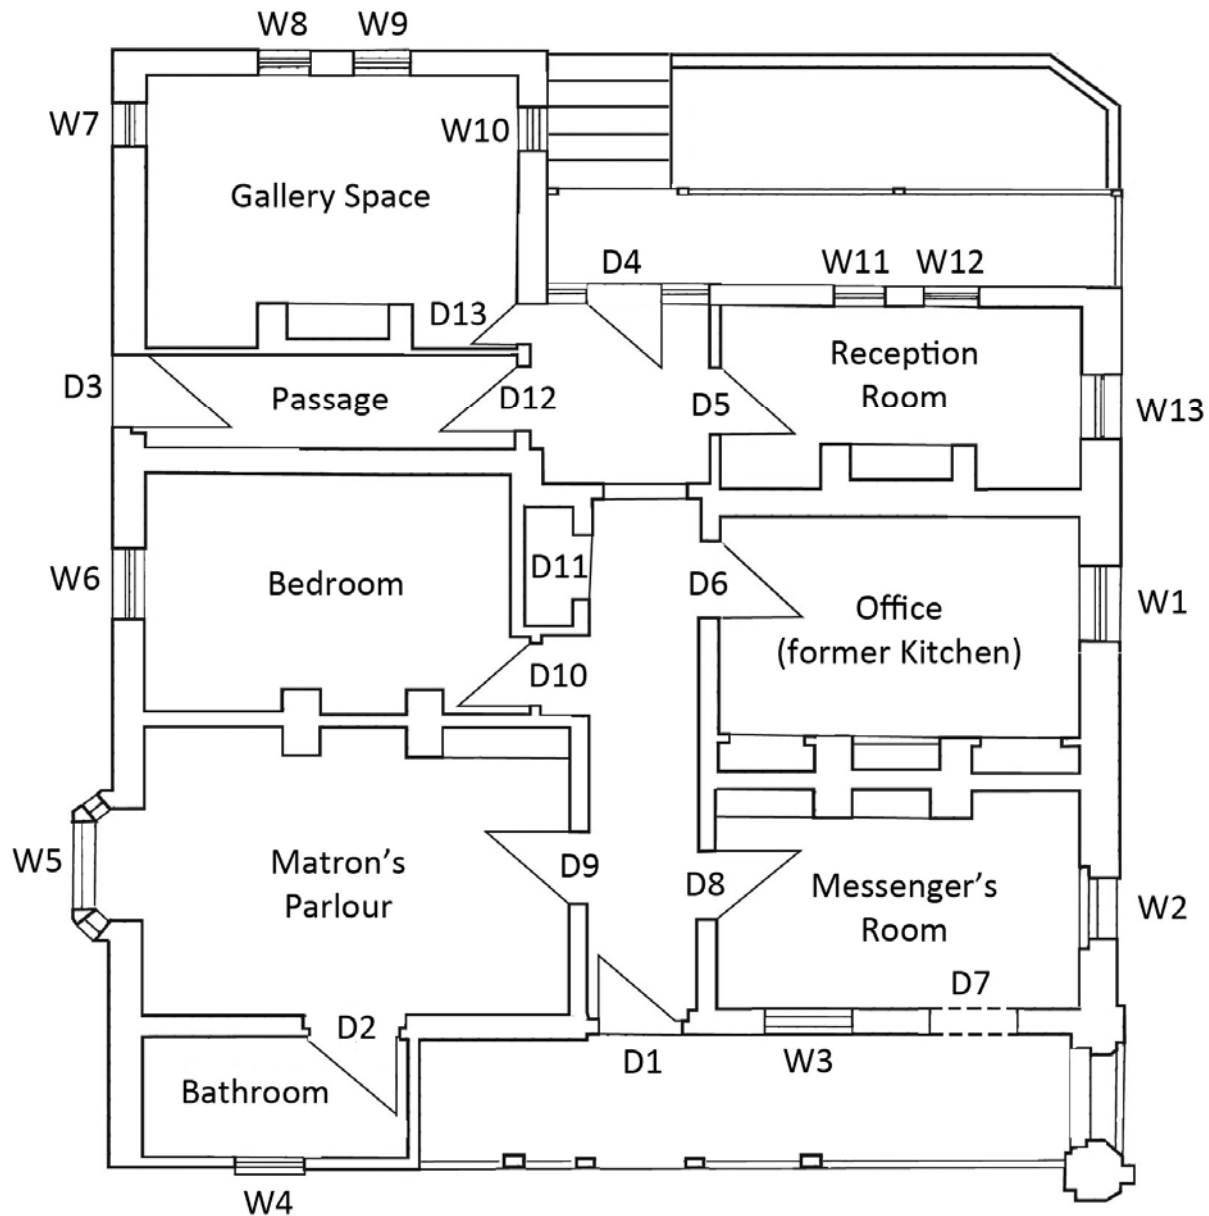
Refer to the plan below for door and window numbers (Source: ERM, modified by HLCD, July 2012)

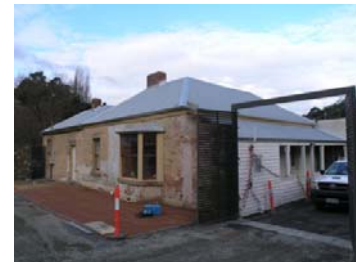
<p>North west elevation</p>

BUILDING AS A WHOLE						
ELEMENT	DESCRIPTION	INTEGRITY	SIGNIFICANCE	CONDITION	ACTION/ RECOMMENDED WORKS	PHOTOGRAPH
Plan form	<p>The four rooms, central corridor and verandah to the Western end which remain from the Convict era layout can easily be understood in the plan. In addition, the full extent of the north brick wall and the south sandstone wall, and the sandstone plinth remain from the convict era with some alterations, including height reduction, removal of buttresses and insertions of new openings.</p> <p>The post 1904, early C20th additions to the east, including enclosure of a passage, two additional rooms and a verandah when the house moved into private ownership can easily be understood in the plan.</p>	<p>High</p> <p>Minor modifications include bricking in of the Messenger's Room door, enclosure of part of the verandah as a bathroom with the window converted to a door and the insertion of two windows in the south wall.</p>	<p>Plan elements from the Convict era are of primary significance.</p> <p>Plan elements from the post 1904, early C20th era of private ownership are of secondary significance.</p>	Good	<p>Remove built-in cupboards in former kitchen (office) and reveal fireplace.</p> <p>Remove bathroom from verandah and reconstruct a window to match the original.</p> <p>Undertake archival recording and measured drawings of The Matron's Quarters, including wall thicknesses and all details.</p>

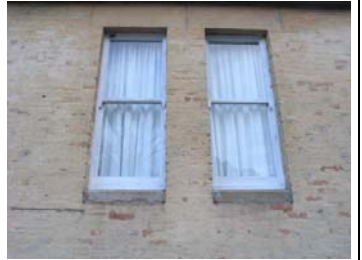
<p>Windows W8 and W9</p>

'BROOKLYN' name plate mounted on timber near door; provenance unknown.			through some bricks.	paint, recording any evidence of earlier layers and reinstate lime wash finish. Remove timber associated with previous meterboard, fill holes, clean.	Lane
Windows (W8 – W12)	Five matching timber framed, double hung, sash windows with simple profile. Sandstone block lintel – drafted margin and tooled finish suggests these stones were from convict wall. Stone sills.	Post 1904, early C20th addition when building in private ownership. High degree of integrity to date of construction.	Contributory	Timber is very weathered; some loss of bead for glass. Horizontal cracks in window sills W11 and W12.	Repair windows. Crack injection to stone sills to W11 and W12 may be required. Remove cement rich repairs around windows. Record evidence of dark red paint.
